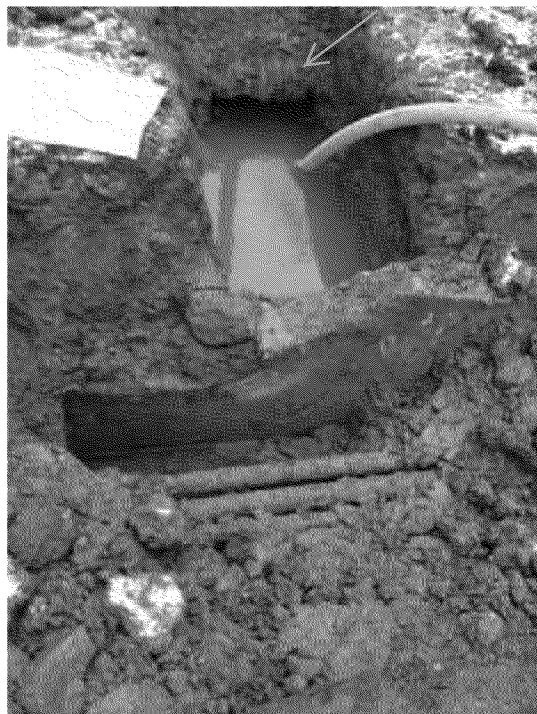
Photo No. IMG\_1606; Taken on 01/19/14 at 11:00 hours by START MD. The contractor excavated a trench inside the wall of the containment area and discovered a compromised corrugated pipe that runs under the site.

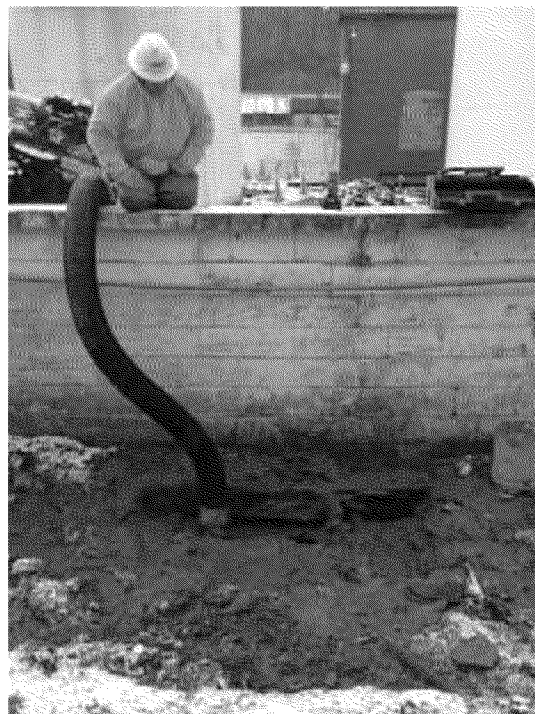
Photo No. IMG\_1610; Taken on 01/19/14 at 11:05 hours by START MD. Contractors continue to pump water from the unknown source located just outside the containment wall.

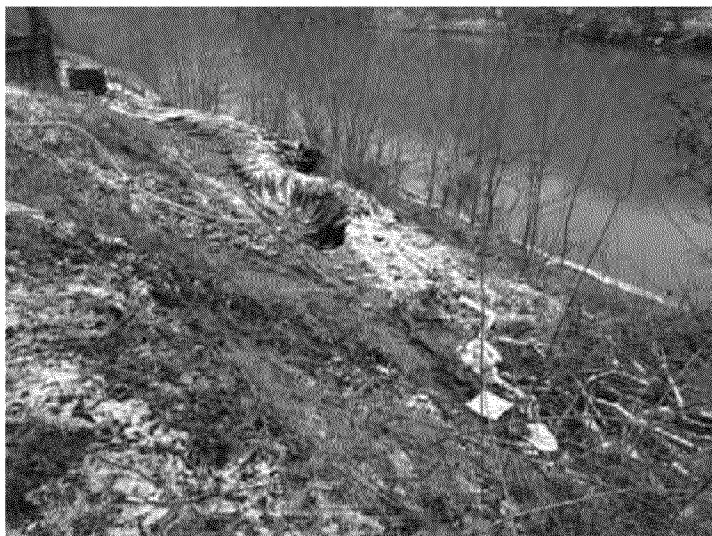
Photo No. IMG\_1619; Taken on 01/19/14 at 11:16 hours by START MD. Standing at the corner of the containment wall, looking down at the Elk River, the trench is visible and has been extended to contain the newly discovered "seep."

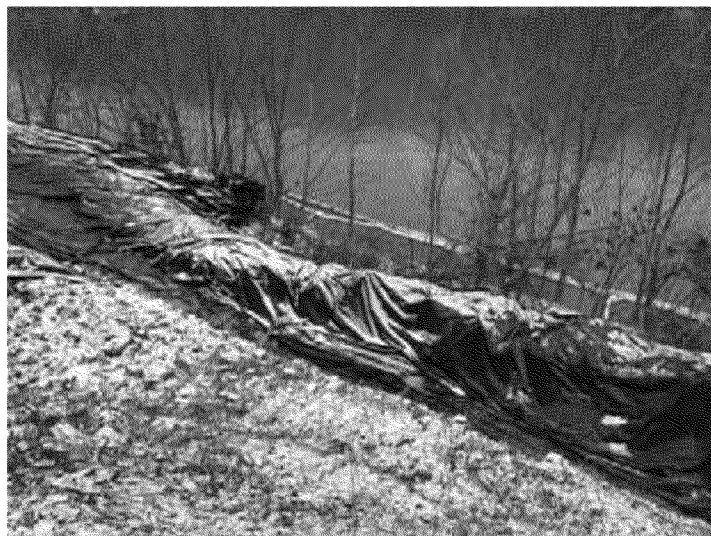
Photo No. IMG\_1622; Taken on 01/19/14 at 11:16 hours by START MD. The trench at the northeastern end of the facility is currently successfully collecting the drainage from the containment area.
